# Manhole Inspection Summary

Manhole # S59K\_\_020MH

Insp Date: **1/7/09 1:19 PM**

**Location** Address: **646 FOSTER AV**

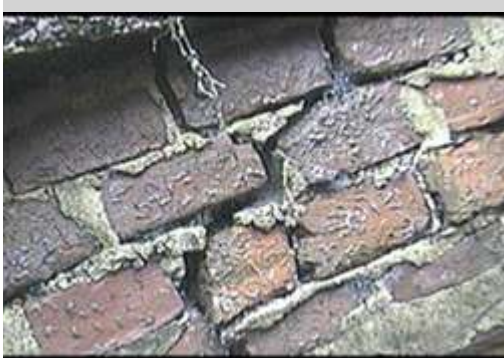
Defect 3

Condition: ☐ Sound ☒ **Cracked** ☐ Root Intrusion ☐ Loose Brick ☐ Deteriorated

CRACK IN CHIMNEY

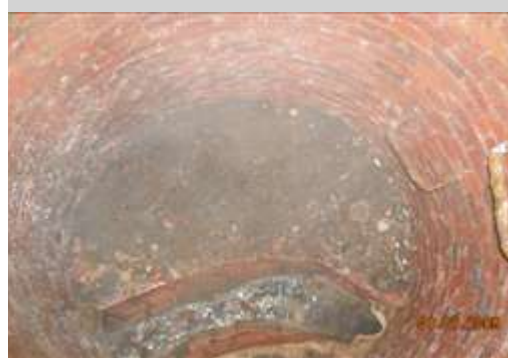
Defect 2

Condition: ☐ Sound ☐ Cracked ☐ Root Intrusion ☐ Deteriorated ☐ Leaks ☒ **Debris**

**Steps** Count: **3** Missing: **0** ☒ **Corroded**

bench debris, steps corroded

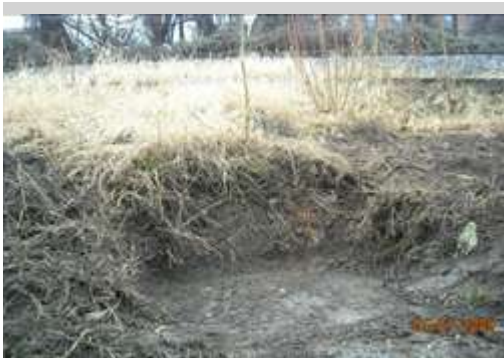
Defect 1

**Cover** Shape: **Circular** Diameter: **24** (in.) Length: **0** (in.) Dist A/B Grade: **-12** (in.)

FRAME BELOW GRADE

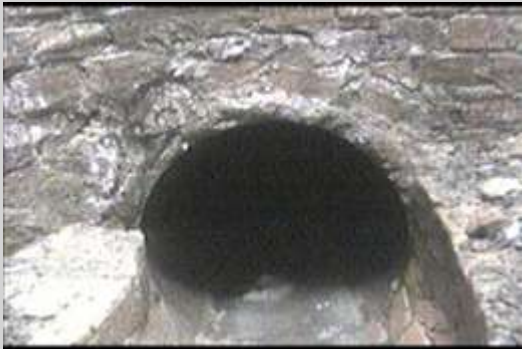
12 O'Clock Outflow

15 in. Circular Gravity Sewer  
Pipe Out @ 12 O'Clock

Pipe Height: **15.6** (in.) Rod and Bar (Angled)  
Pipe Material: **Clay** ☐ Pipe Lined  
Invert Depth: **7.76** (ft.) Flow Characteristics: **Slow**  
Deposits: ☒ None ☐ Mud ☐ Sludge ☐ Debris ☐ Grease  
Silt Depth: **0** (in.) Deposits Extent:  
Infiltration: **None** Pipe Seal Cond: **Sound**

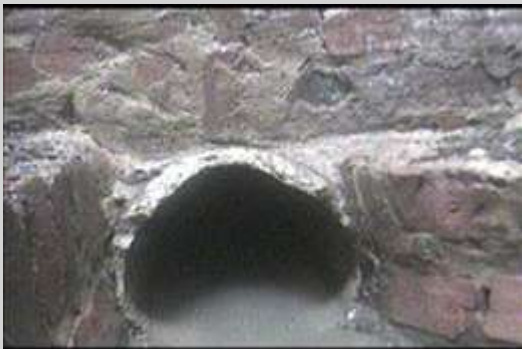
8 O'Clock Inflow

8 in. Circular Gravity Sewer  
Pipe In @ 8 O'Clock

Pipe Height: **8.4** (in.) Rod and Bar (Angled)  
Pipe Material: **Clay** ☐ Pipe Lined  
Invert Depth: **7.60** (ft.) Flow Characteristics: **Slow**  
Deposits: ☒ None ☐ Mud ☐ Sludge ☐ Debris ☐ Grease  
Silt Depth: **0** (in.) Deposits Extent:  
Infiltration: **None** Pipe Seal Cond: **Sound**
